# Perimeter Fire Barrier Systems

Taking a team approach  
to fire-safe construction

by Tony Crimi, P.Eng., M.A.Sc.

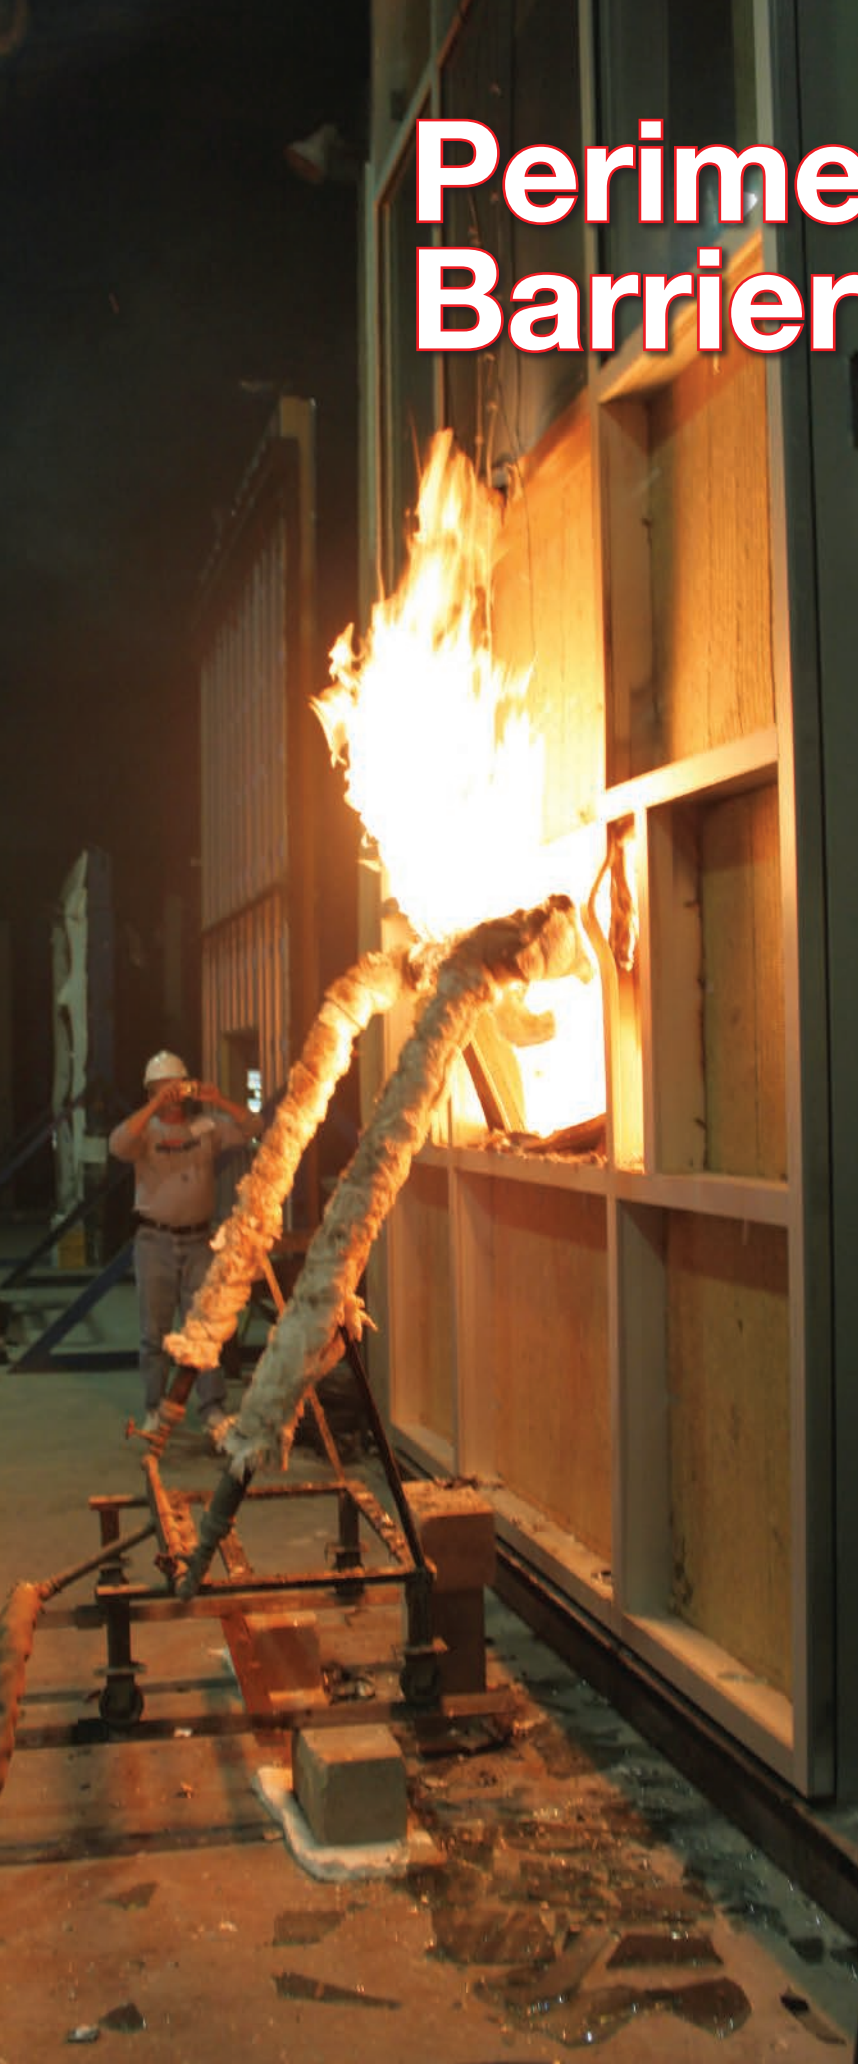
A large fire is burning through a building's exterior wall and floor edge. A worker in a hard hat and safety gear is visible in the background, observing the fire. The fire is intense, with bright orange and yellow flames. The building's structure is visible, showing a mix of concrete and metal elements. The fire appears to be spreading through a void space between the wall and the floor edge.

When there is ineffective curtain wall and perimeter void protection, a fire can spread through the space between floors and walls, and the window head transom and the cavity of the curtain wall, as well as through broken glass or around melted aluminum spandrel panels.

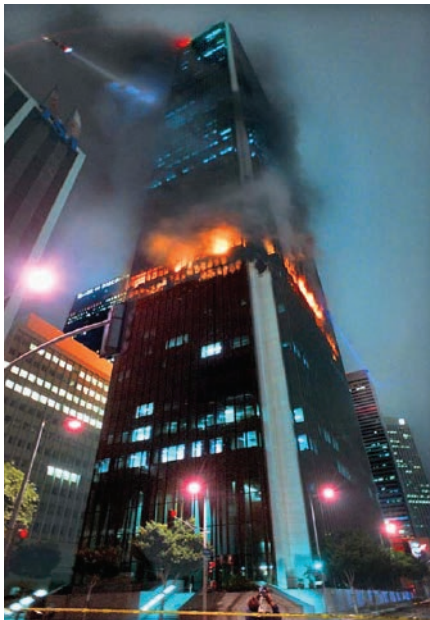
On February 12, 2005, a fire started on the 21<sup>st</sup> floor of the Windsor Tower or Torre Windsor (officially known as Edificio Windsor) in Madrid, Spain. The building was a 32-story concrete building with a reinforced concrete central core. It was not sprinklered, and had been undergoing progressive refurbishment over a three-year period. The fire burned

for 20 hours, spreading to all levels above the second floor.

At the time of construction, the Spanish building code did not require perimeter firestopping or perimeter columns and internal steel beams to be fire-protected. As a result, the original existing steelwork was left unprotected and the gap between the original

cladding and floor slabs was not firestopped. In fact, these weak links in the fire protection of the building were being rectified in the refurbishment project at the time of the fire. Since the building adopted the ‘open-plan’ floor concept, effectively, the fire compartmentation could only be floor-by-floor (about 40 x 25 m [131 x 82 ft]). However, the lack of perimeter fire barriers in floor openings and between the original cladding and the floor slabs led to a failure of the vertical compartmentation, and the complete collapse of the building.

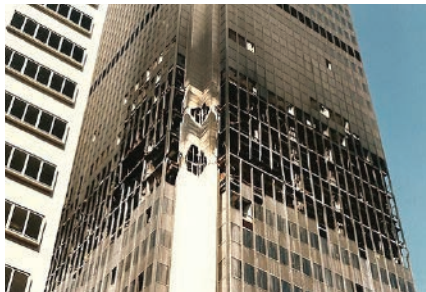
In 1988, the 62-story First Interstate Bank Building (Los Angeles) caught fire on the 12th floor, quickly spreading to other levels after combustibles in workstations ignited. The exterior glass panels broke, providing additional oxygen, and an alternate path for the fire to travel. Flames spread through the gap in the joint between the floor/ceiling slab and the curtain wall. (The building was being retrofitted with sprinklers at the time, but the system was not operational.)

There have been multiple cases showing what kind of damage can be done when fires move through improperly protected concealed spaces. In 1988, the 62-story Los Angeles tower, First Interstate Bank building, caught fire on its 12<sup>th</sup> floor. The fire spread to the 16<sup>th</sup> floor on the building after the combustibles in work stations ignited and rapidly grew. The exterior glass panels began to break, providing both additional oxygen and an alternate path for the fire to travel.

Flames spread through the gap in the joint between the floor/ceiling slab and the curtain wall. The fire vented through broken windows, first preheating combustibles on floors above before eventually igniting their contents. The building was being retrofitted with sprinklers at the time, but the system was not operational, so the fire was free to spread and grow. The fire was finally contained by firefighters after 3.5 hours.

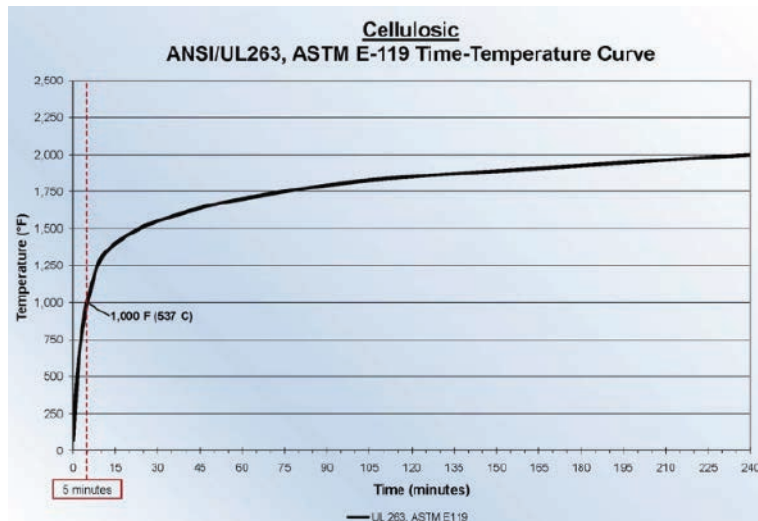
ASTM E119 fire exposure temperatures are based on a cellulosic time-temperature curve developed in the early 1900s.

In 2004, ASTM E2307 was developed. Evaluating the interface between a fire-resistance-rated horizontal assembly and an exterior curtain wall, this test method is used to measure and describe the response of materials, products, or assemblies to heat and flame under controlled conditions. However, it does not by itself incorporate all factors required for the fire-hazard or fire-risk assessment of the materials, products, or assemblies under actual fire conditions, using a test structure called the Intermediate-scale, Multi-story Test Apparatus (ISMA).

The ISMA test simulates fire exposure in a high-rise structure where, as the fire intensifies and positive pressure builds, a fire-induced window break occurs, allowing oxygen to feed the flames. The method is meant to simulate a fire in a post-flashover condition in a compartment venting to the exterior.

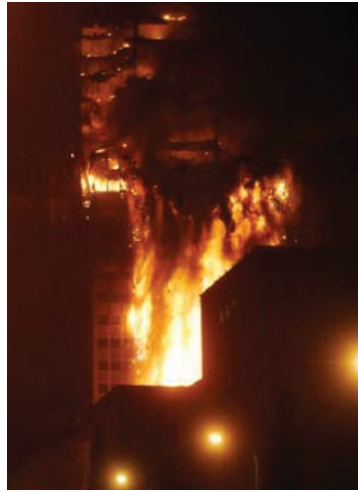
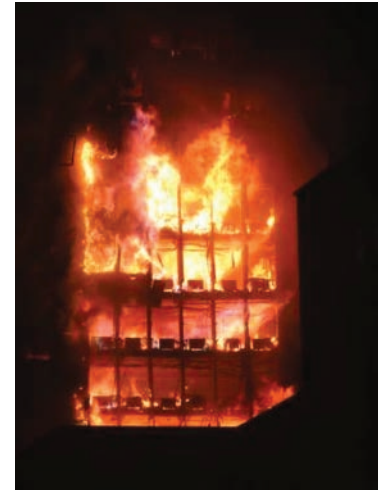
In 2005, a fire started on the 21st floor of Torre Windsor in Madrid. The 32-story concrete building, with a reinforced concrete central core, was not sprinklered, and had been undergoing progressive refurbishment over a three-year period. At the time, the Spanish building code did not require perimeter firestopping or perimeter columns and internal steel beams to be fire-protected.
